YRC1000 ALARM CODES (MAJOR ALARMS)

MANUAL NO. RE-CER-A600

MAJOR ALARMS

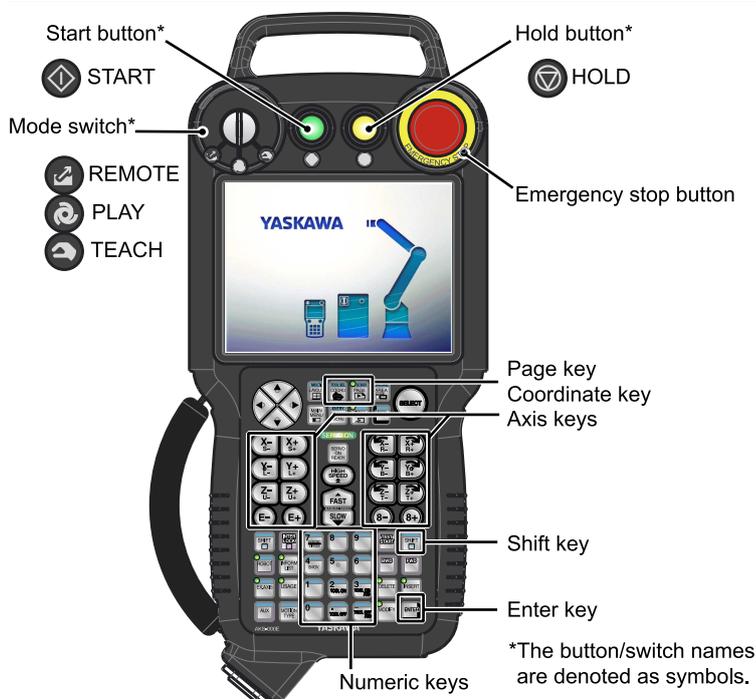
Equipment	Manual Designation	
Programming Pendant	Character Keys/Symbol Keys	The keys which have characters or symbols printed on them are denoted with []. e.g. [ENTER]
	Axis Keys/Numeric Keys	[Axis Key] and [Numeric Key] are generic names for the keys for axis operation and number input.
	Keys pressed simultaneously	When two keys are to be pressed simultaneously, the keys are shown with a “+” sign between them, e.g. [SHIFT]+[COORD].
	Mode Switch	Mode Switch can select three kinds of modes that are denoted as follows: REMOTE, PLAY or TEACH. (The switch names are denoted as symbols)
	Button	The three buttons on the upper side of the programming pendant are denoted as follows: START, HOLD, or EMERGENCY STOP. (The button names are denoted as symbols)
	Displays	The menu displayed in the programming pendant is denoted with { }. e.g. {JOB}

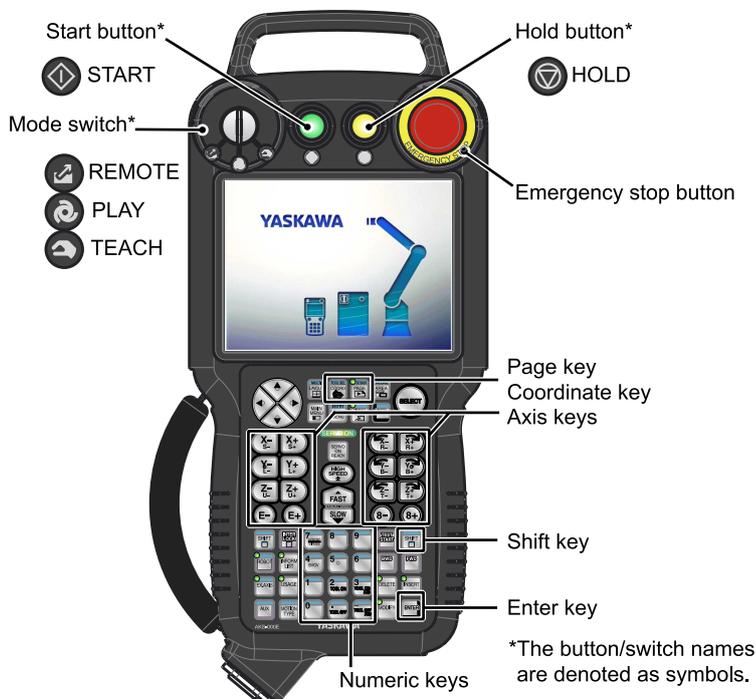
Equipment	Manual Designation	
Programming Pendant	Character Keys/Symbol Keys	The keys which have characters or symbols printed on them are denoted with []. e.g. [ENTER]
	Axis Keys/Numeric Keys	[Axis Key] and [Numeric Key] are generic names for the keys for axis operation and number input.
	Keys pressed simultaneously	When two keys are to be pressed simultaneously, the keys are shown with a “+” sign between them, e.g. [SHIFT]+[COORD].
	Mode Switch	Mode Switch can select three kinds of modes that are denoted as follows: REMOTE, PLAY or TEACH. (The switch names are denoted as symbols)
	Button	The three buttons on the upper side of the programming pendant are denoted as follows: START, HOLD, or EMERGENCY STOP. (The button names are denoted as symbols)
	Displays	The menu displayed in the programming pendant is denoted with { }. e.g. {JOB}
